DeBeque Canyon Landslide, Colorado

October 9, 2013

Image Map Created by the USGS Geosciences and Environmental Change Science Center, Denver, CO

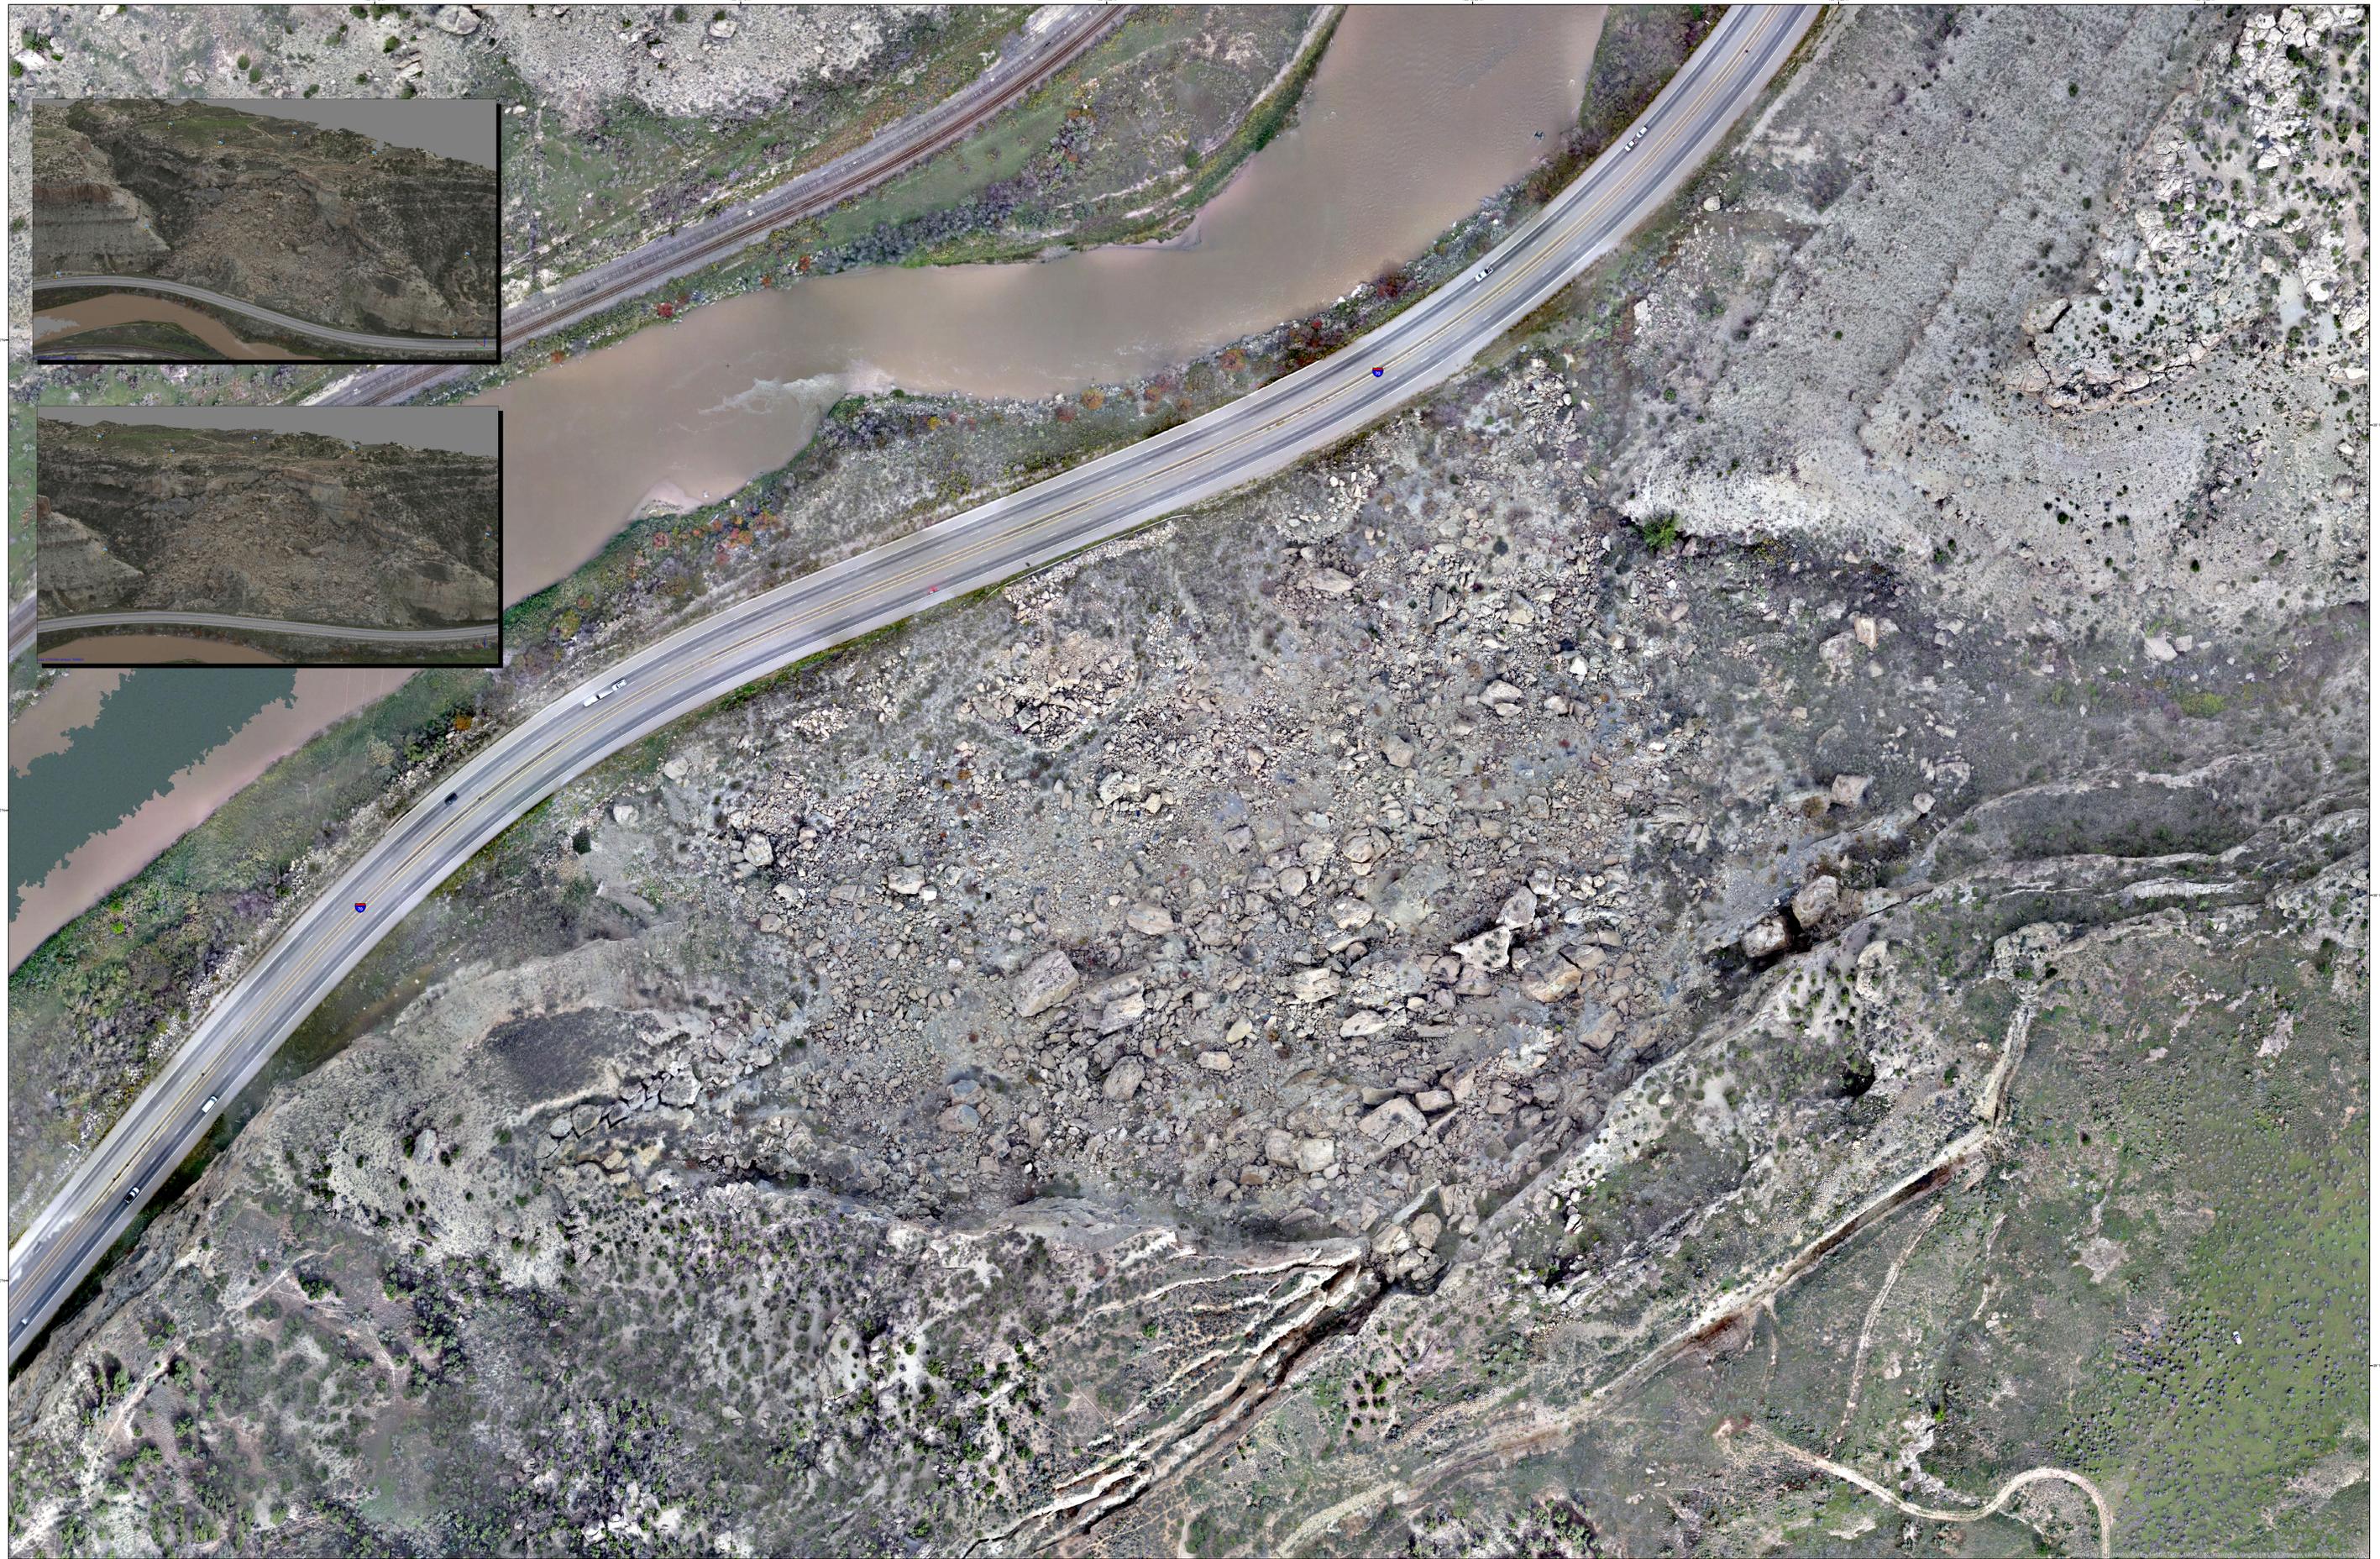
The ortho image on this map was collected June 20th, 2013 using a Falcon system unmanned aerial vehicle (UAV). The image is composed of 650 overlapping images taken with a Canon sx250, 12 imperial point and shoot camera. The resulting ground sampled distance of this image is approximately 1.79 inches, 4.56 centimeters. The project was a collaboration between the U.S. Geological Survey, Colorado State Geological Survey, the Bureau of Land Management, and the Mesa County Sheriff's office.

The DeBeque Canyon Landslide is a major landslide complex in western Colorado that has historically impacted the east-west highway and railway corridor on the Colorado River. These significant reactivations or ground movements have occurred during the past century. The precise date of the first major movement is unknown but occurred in the late 1890s or early 1900s. This slide movement was the largest and reportedly shifted the river channel and damaged railroad facilities on the north bank of the Colorado River.

The second noteworthy movement occurred in February 1958 when the roadway was widened for a modern two-lane highway. The widening resulted in further cutting and destabilizing of the landslide toe, with subsequent movements resulting in the heaving of the roadway 23 vertical feet. In April 1968, the final major movement occurred and caused Interstate 70, constructed in the mid-1960s, to heave 14 vertical feet. The highway also shifted 5 to 6 feet laterally toward the river during this event. It was only by the rapid response of the Colorado Department of Transportation (CDOT) that Interstate 70 was not completely closed and the only major east-west interstate corridor in Colorado blocked.
